HIGHWAY 10 STEP INNOVATION STUDY (Little Rock) (S)

FINAL TRAFFIC REPORT

Prepared by Garver for the
City of Little Rock and Metroplan
In cooperation with the Federal Highway Administration

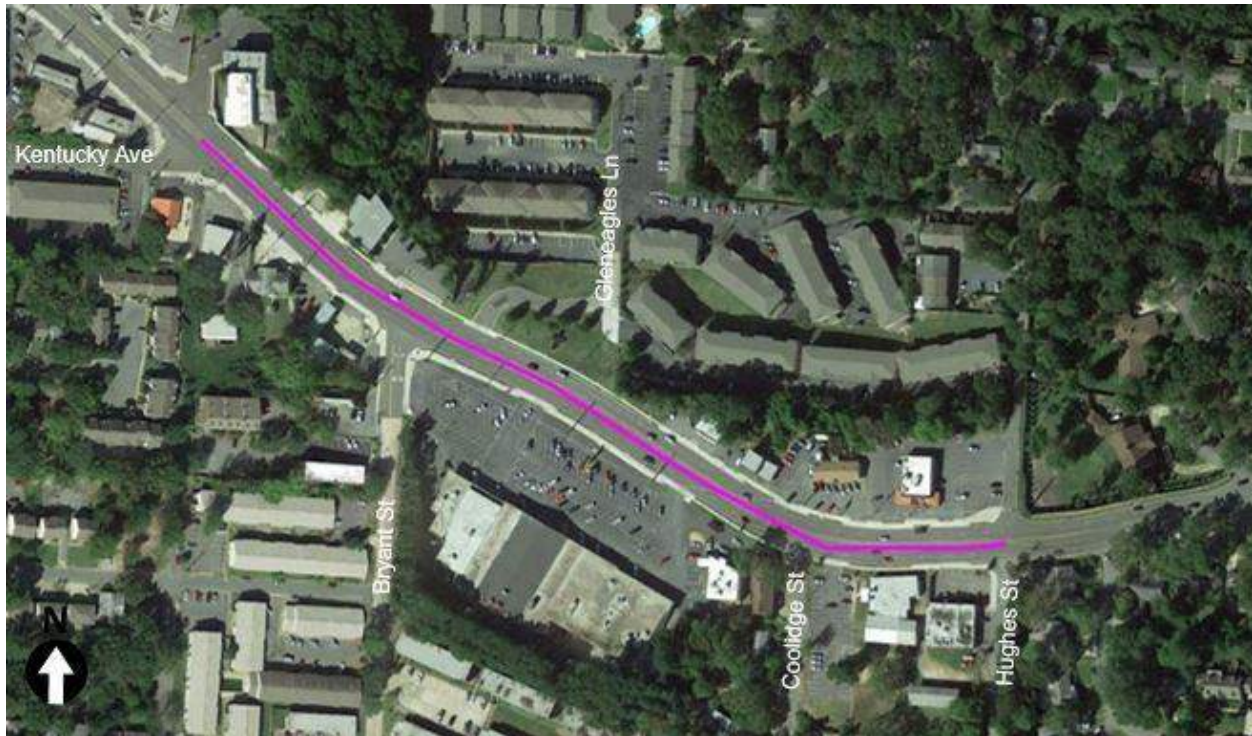
Figure 1: Highway 10 Study Corridor

Highway 10, also known as Cantrell Road, serves as a principal arterial facility through Little Rock. The study area extends from Kentucky Street on the west end to Hughes Street on the east end. The posted speed limit is 35 miles per hour (mph). This segment of Highway 10 contains four traffic lanes and a two-way left turn lane (TWLTL) with sidewalks along both sides of the roadway. The TWLTL was installed on May 26, 2016. Three bus stops are located within the study area: one at Bryant Street, one at Coolidge Street, and one at Gleneagles Lane. There are also two bus stops just outside of the study area located west of Kentucky Avenue. A map of the study corridor is shown in **Figure 1** on the following page.

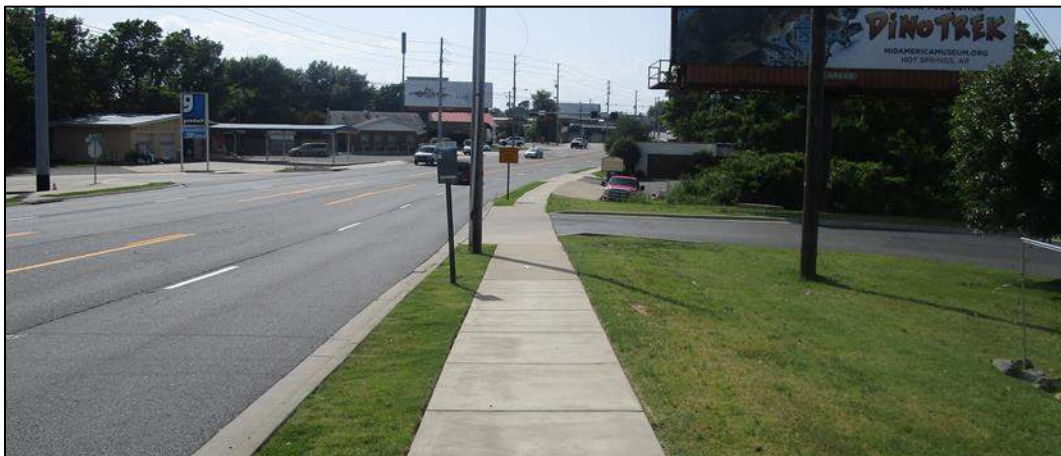
Figure 2: Bus Stop at Highway 10 and Gleneagles Lane

In the AM peak period, school buses drive through the area and were observed loading at the bus stop located on the northeast corner of Highway 10 and Gleneagles Lane shown in **Figure 2**. No shelter or bench are currently provided at this bus stop. School children were seen sitting on the landscaping wall around the monument sign for the Legacy Pointe Apartments near the Highway 10 bus stop while waiting for the school buses. In the PM peak period, school buses unloaded school children at this same bus stop. The school buses load and unload directly on Highway 10. No METRO bus made stops at the Gleneagles Lane bus stop during AM and PM observations.

- Provide a bench and shelter at the bus stops located at Gleneagles Lane and at Coolidge Street.
- Provide a shelter at the bus stop located at Bryant Street.

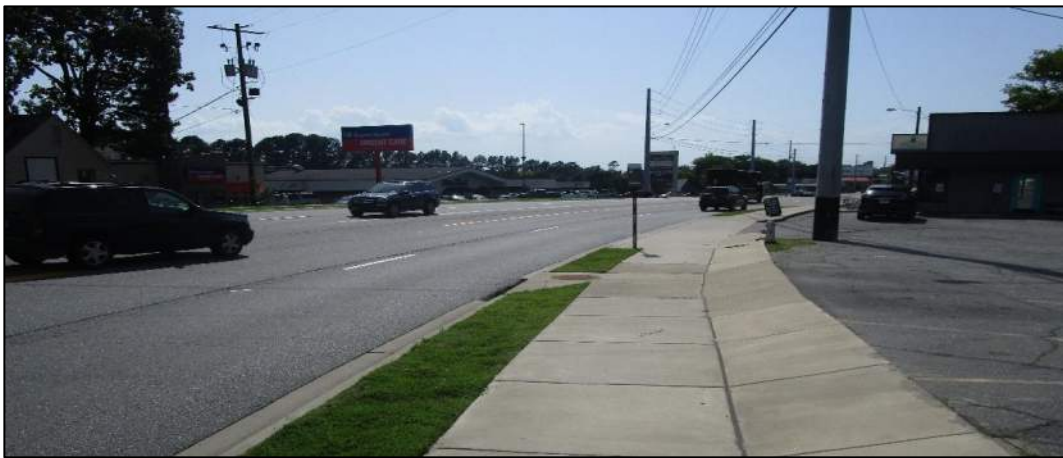
Figure 3: Bus Stop at Highway 10 and Coolidge Street

Two other METRO bus stop locations exist within the study area: on the north side of Highway 10 at Coolidge Street and on the southwest corner at Bryant Street as shown in **Figures 3 and 4**, respectively. The bus stop at Coolidge Street lacks a bench and shelter while the bus stop at Bryant Street has a bench but no shelter.

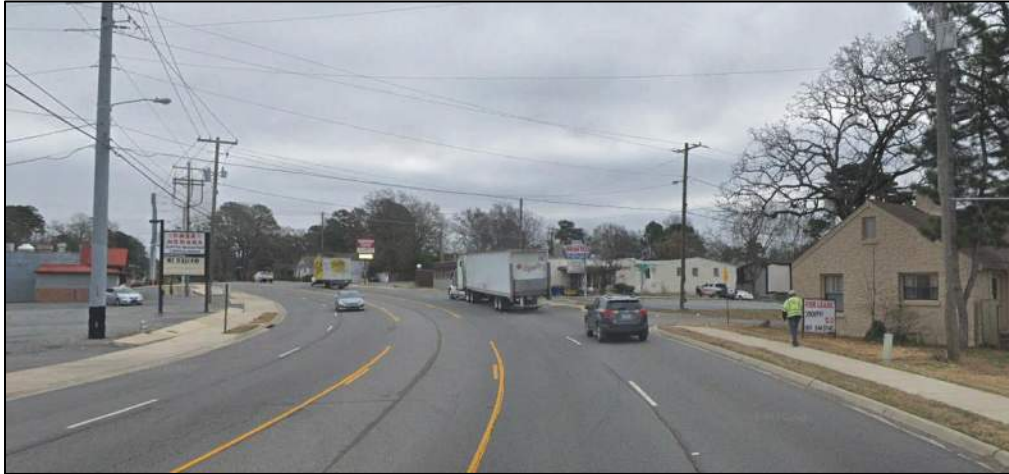
Figure 5: Pedestrians Walking along Highway 10

During the AM observations, several pedestrians were observed walking along the sidewalks on both sides of the roadway as shown in **Figure 5**. The majority of the pedestrians came from the Legacy Pointe Apartments and Bryant Street. Six pedestrians were noted boarding the METRO bus at Bryant Street during the AM peak hour. Three of the six pedestrians crossed Highway 10 from the Legacy Pointe Apartments to board the bus. During the PM observations, a pedestrian was seen crossing Highway 10 to the Legacy Pointe Apartments from the same bus stop. The majority of the pedestrians crossing Highway 10 quickly walked or ran across when there was a sufficient gap. A pedestrian crossing Highway 10 between Kentucky Avenue and Bryant Street was observed to stop in the center turn lane for oncoming traffic before continuing to cross. No bicycles were noted during the site visit.
